RESIDENTIAL REPORT

1247 Maple Ridge Lane, Springfield, IL

May 13, 2026

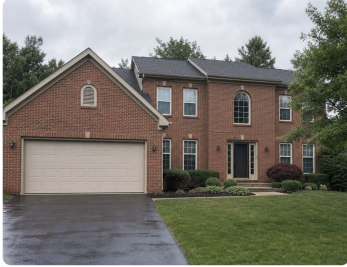
2.1 Wall Cladding and Trim

Brick veneer in good condition overall. Mortar joints intact with no significant spalling or cracking. Weep holes present and clear at base course. Exterior paint on trim in good condition.

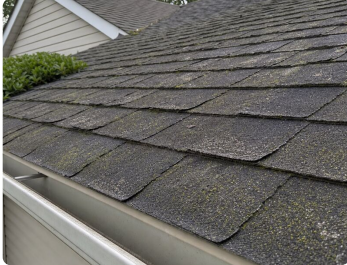
3.1 Roof Coverings

Asphalt shingle roof is near the end of its useful service life. Significant granular loss visible on multiple slopes. Several shingles exhibit curling and lifting at edges. Algae staining present throughout. Recommend full roof replacement by a licensed roofing contractor within 1-2 years or sooner if leaks develop.

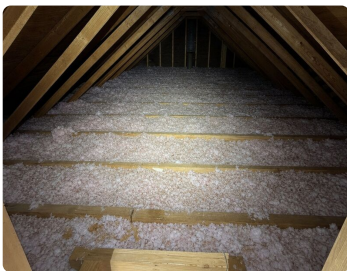
4.2 Insulation

Blown-in fiberglass insulation present but depth is insufficient, averaging approximately 4 inches in most areas. Current minimum recommendation is R-38 (approximately 12 inches of blown fiberglass). Recommend adding insulation to achieve current energy code minimums, which will improve heating and cooling efficiency.

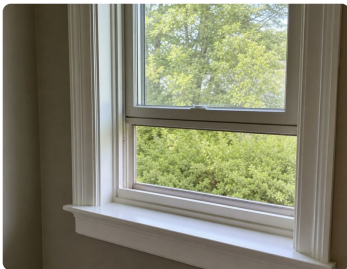
12.3 Bedroom #3

Third bedroom functional. Window sash operational but the rough opening width measures approximately 18 inches, which falls below the 20-inch minimum egress width required by current residential codes for sleeping rooms. Recommend evaluation by a licensed contractor to determine if window replacement or enlargement is warranted for life-safety compliance.

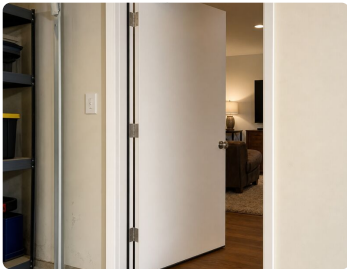
16.3 Fire Separation

Garage-to-living-space door is solid-core with self-closing hinges. Door seals properly. No penetrations observed in common wall between garage and living space.
